**The World War II and Early Cold War Architectural Legacy
of Holloman Air Force Base (ca. 1942-1962)**

**by
Martyn D. Tagg**

**Holloman Air Force Base
Cultural Resources Publication No. 6**

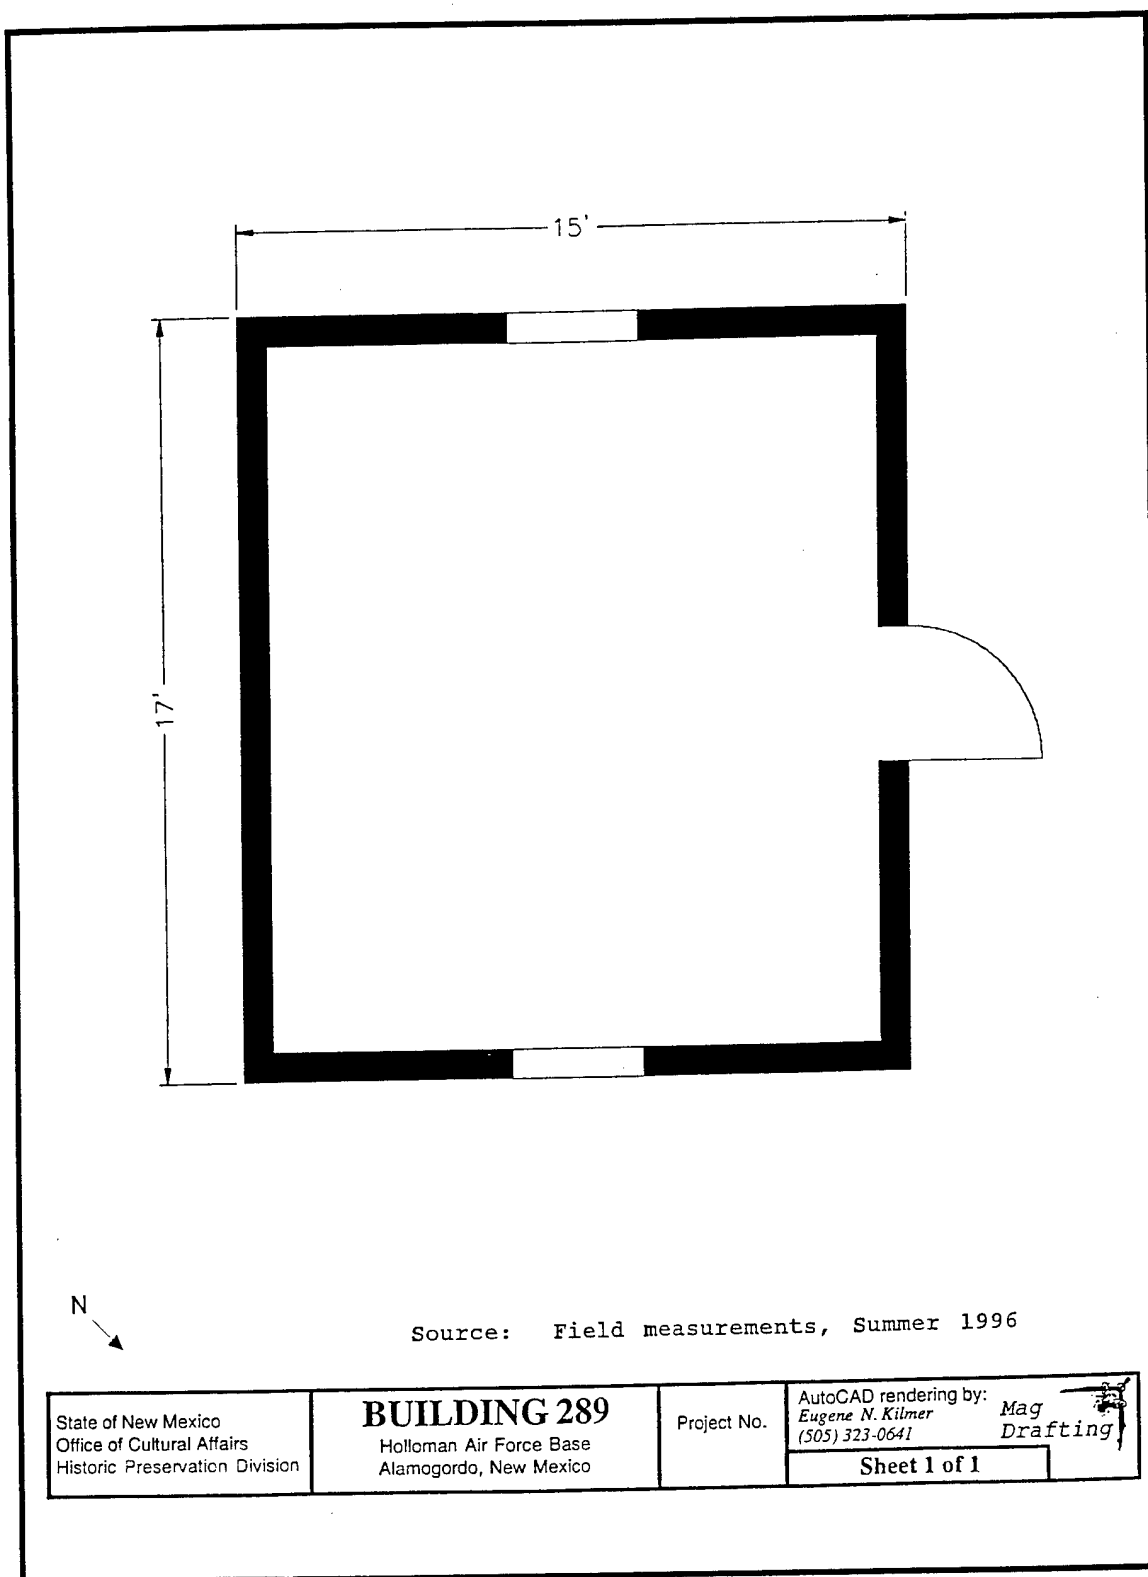
Figure 42. Building 289, floor plan as an Aircraft Support Equipment Storage facility in 1996.

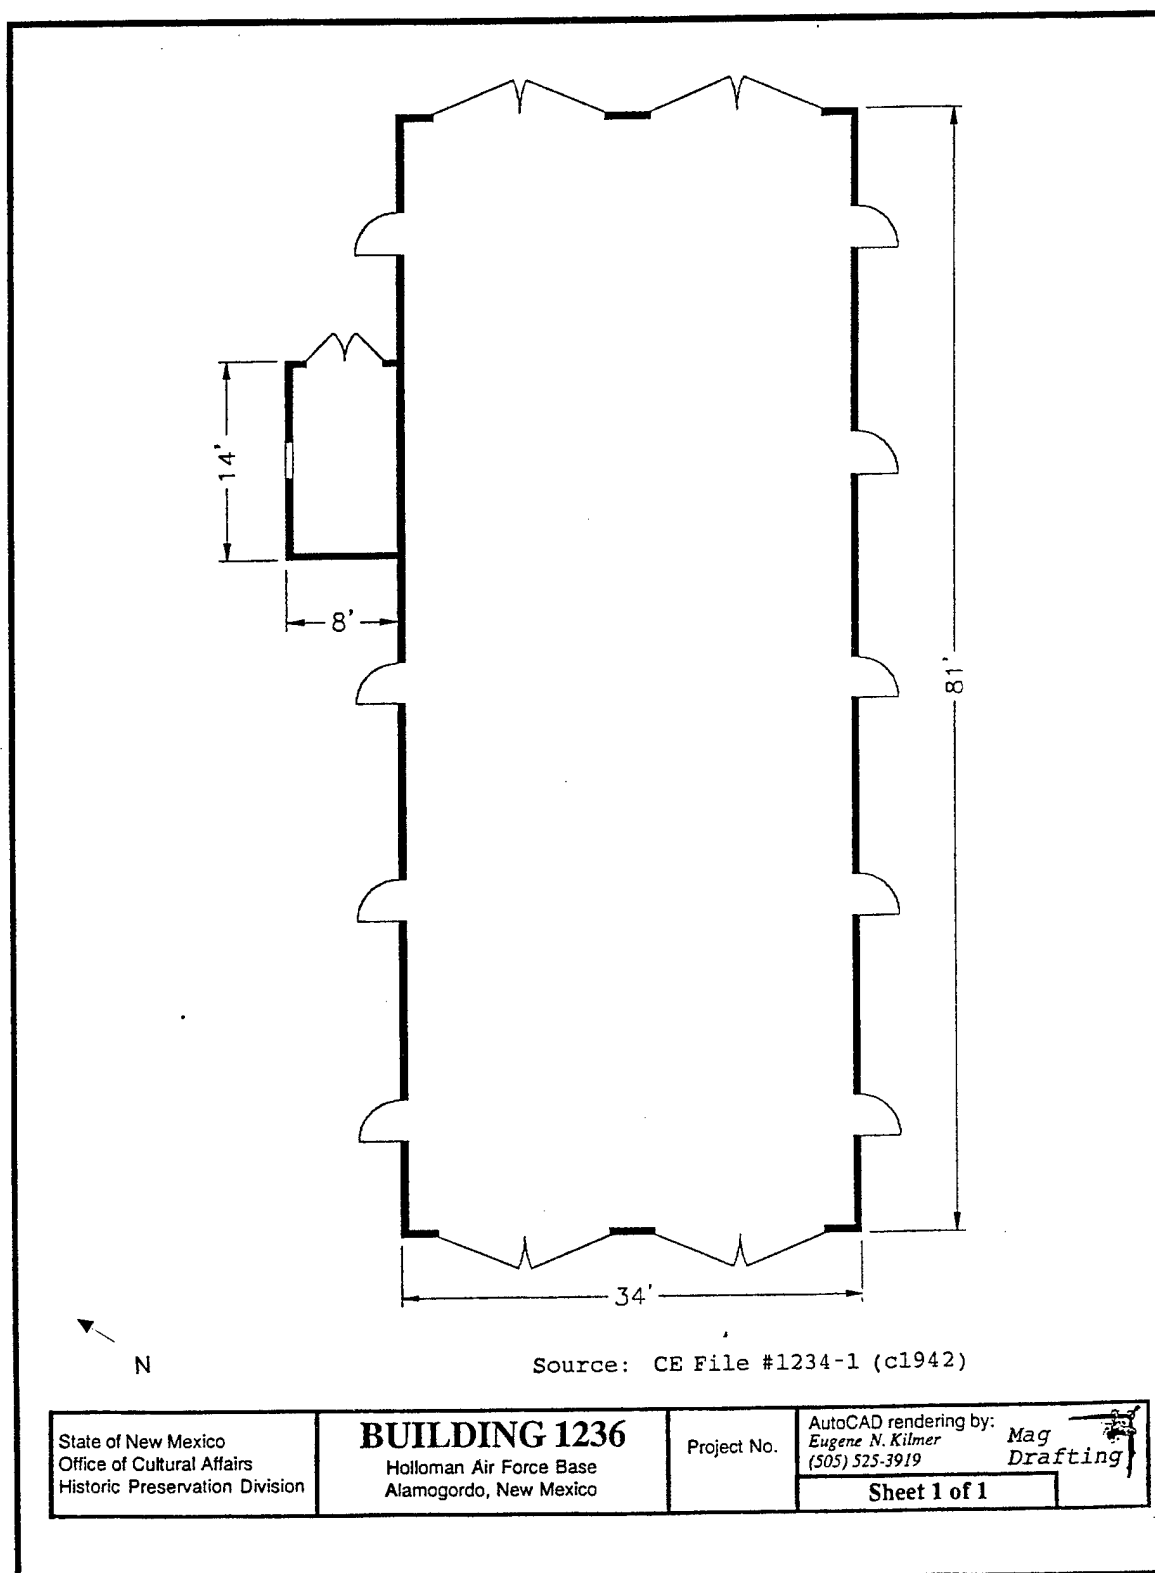
Figure 44. Building 1236, floor plan as a Spare Inert (Munitions) Storage facility, ca. 1942.

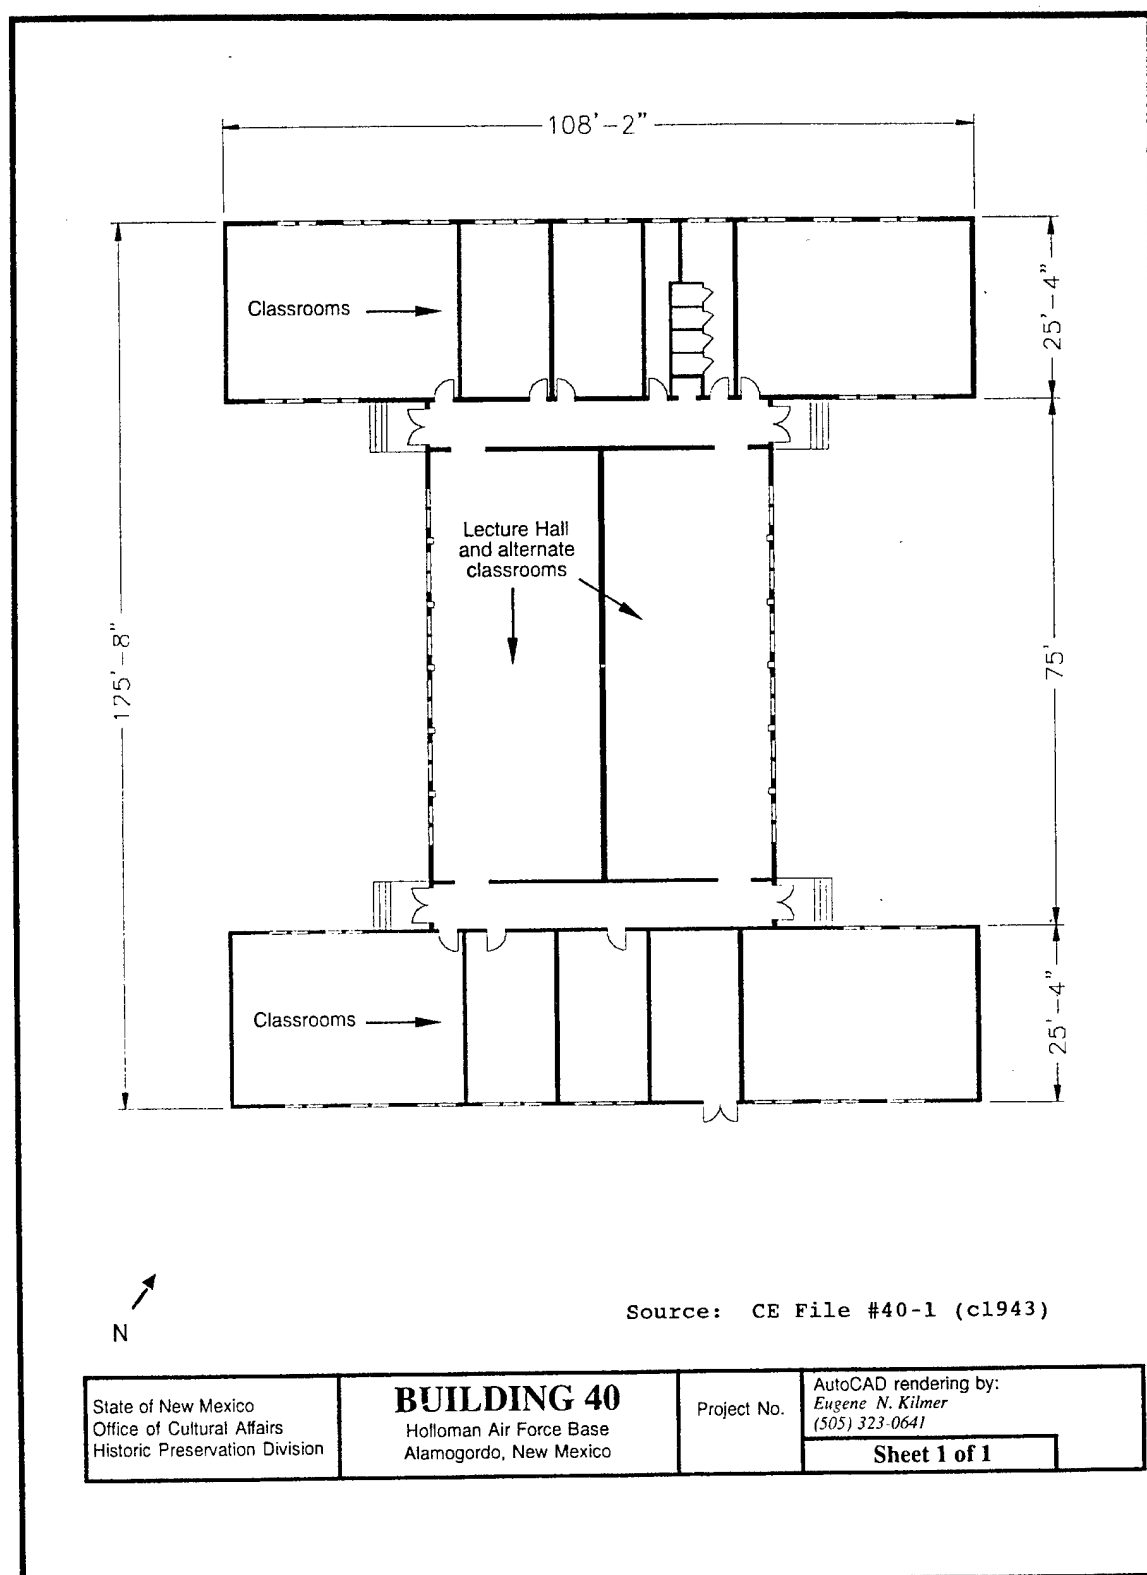
Figure 50. Building 40, floor plan as an Academic Classroom School facility, ca. 1943.

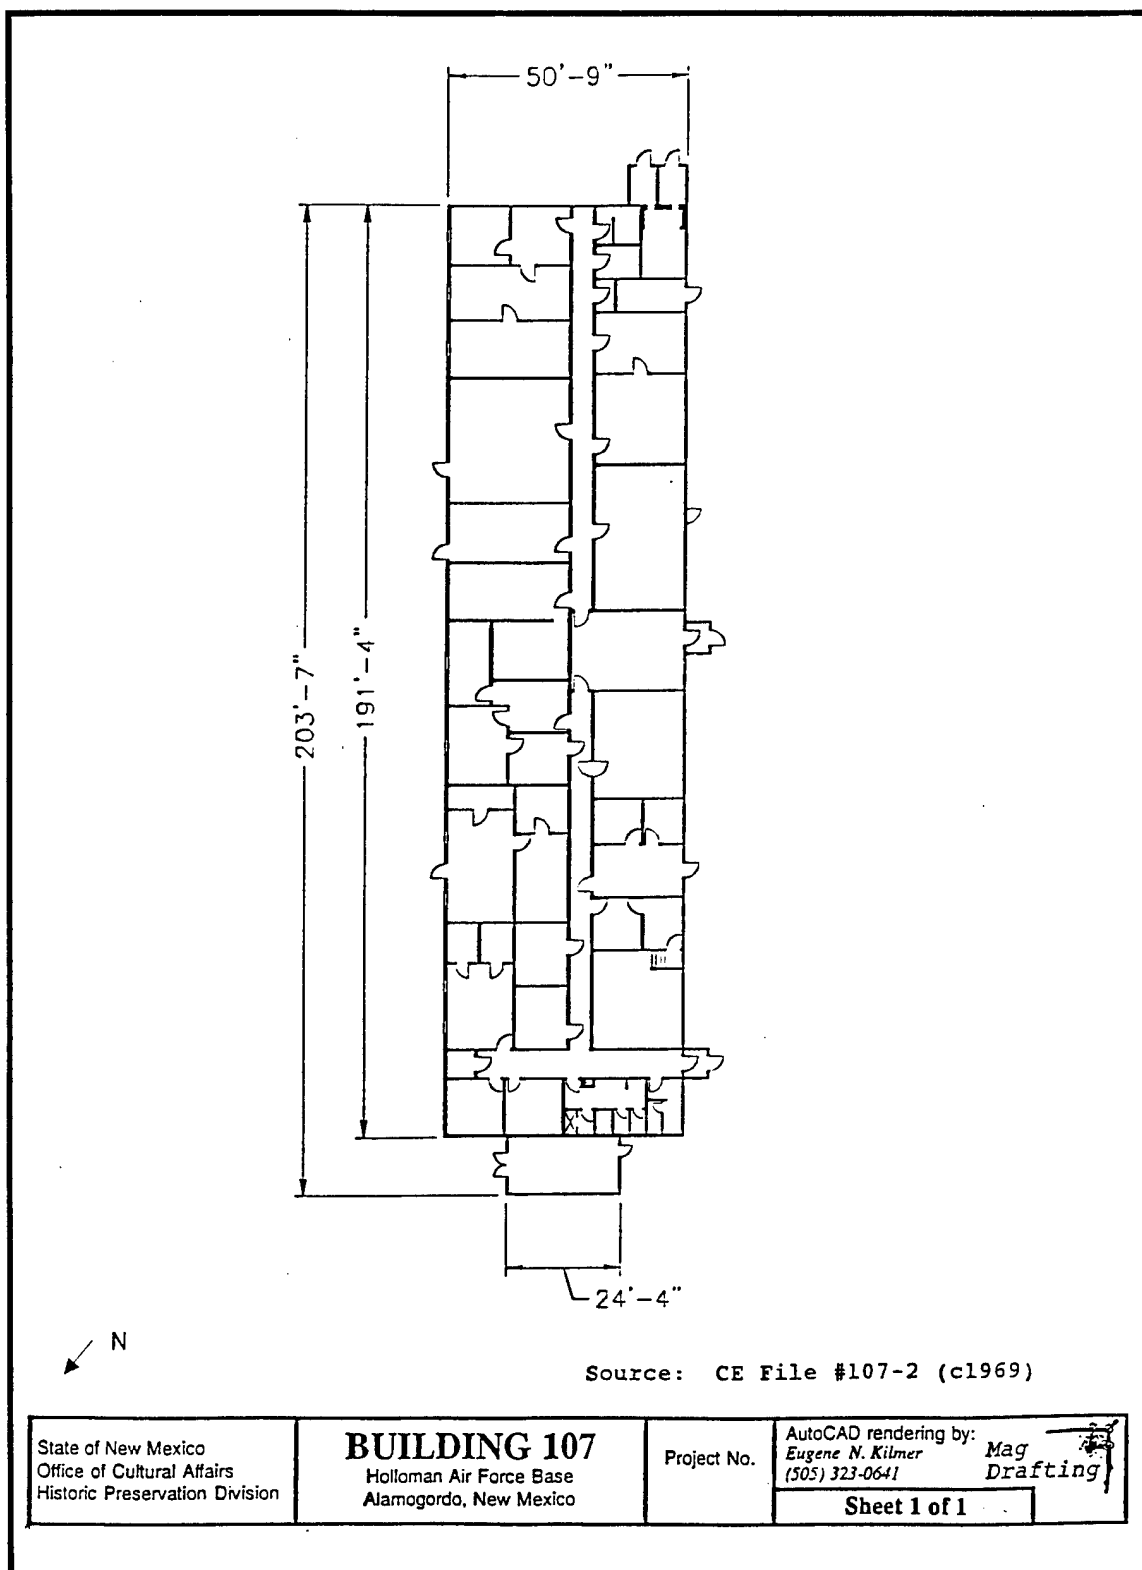
Figure 52. Building 107, floor plan as an Administrative Office, ca. 1969.

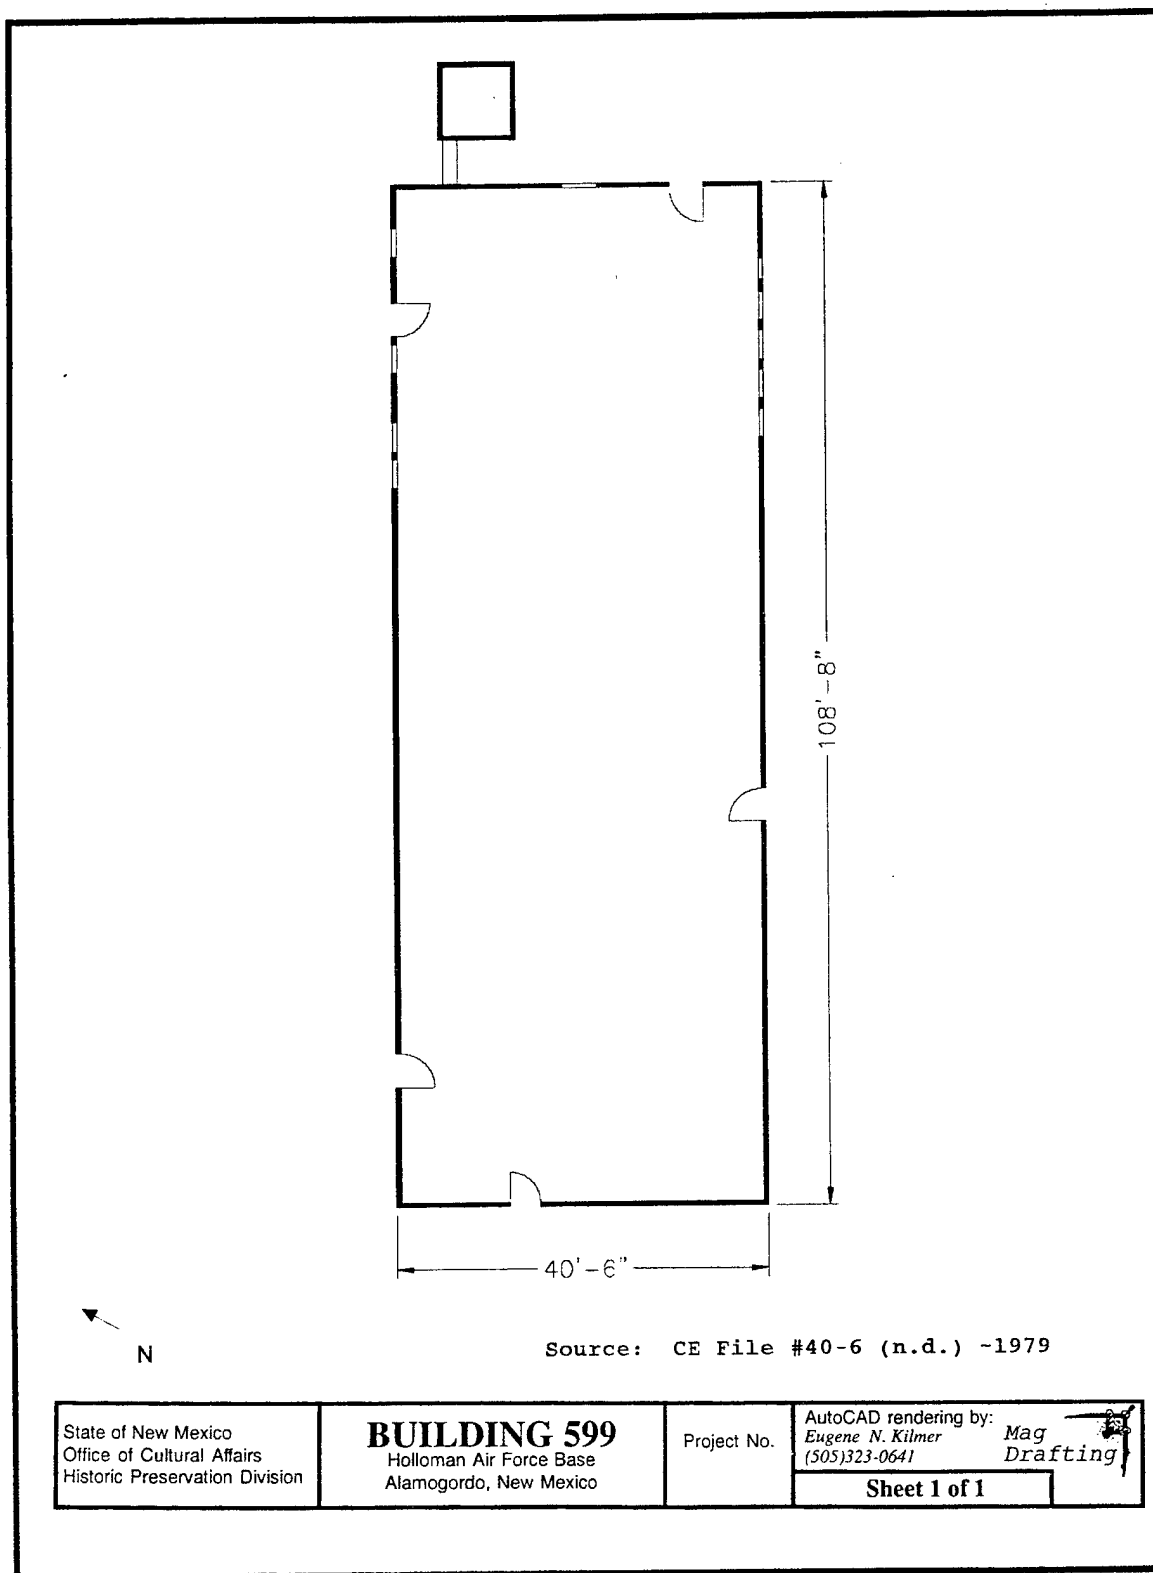
Figure 54. Building 599, floor plan as a Small Arms Training facility(?), ca. 1979.

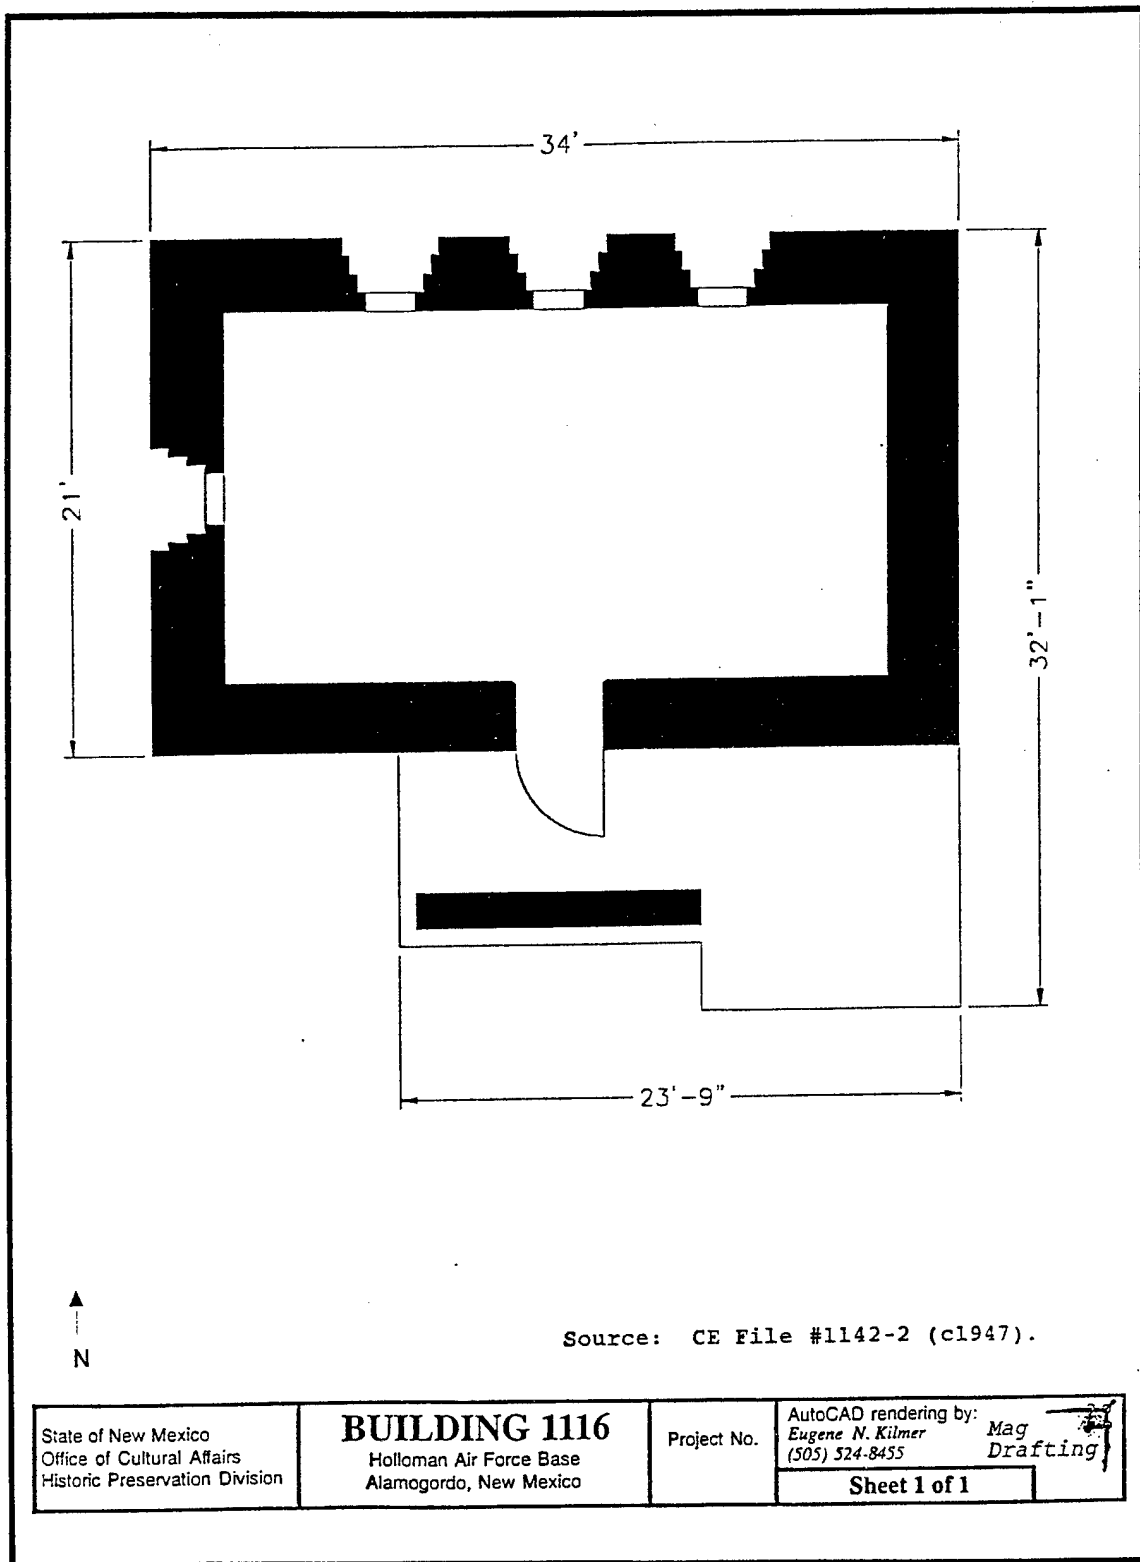
Figure 68. Building 1116, floor plan of the Nativ blockhouse, ca. 1947.

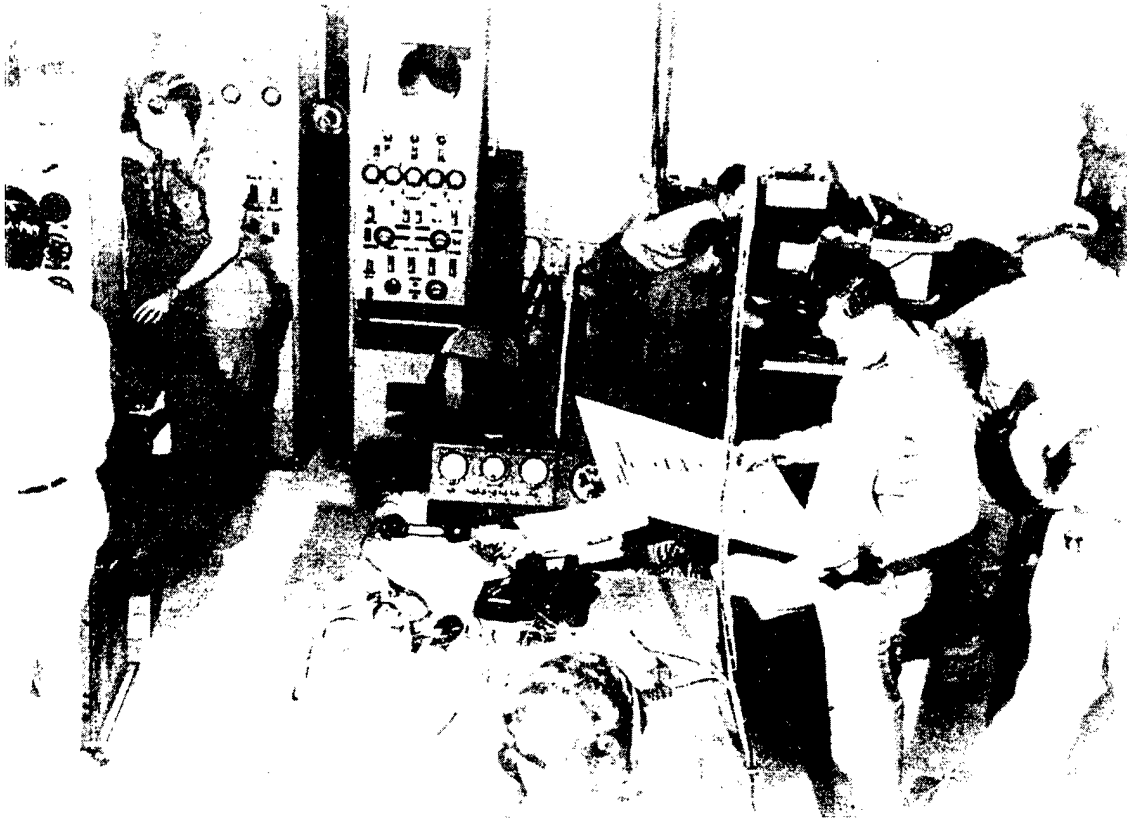
Figure 69. Interior of Building 1116, the Nativ blockhouse, showing instruments and military personnel during countdown, ca. 1948 (HAFB Environmental Flight, Cultural Resources Photo Archives).

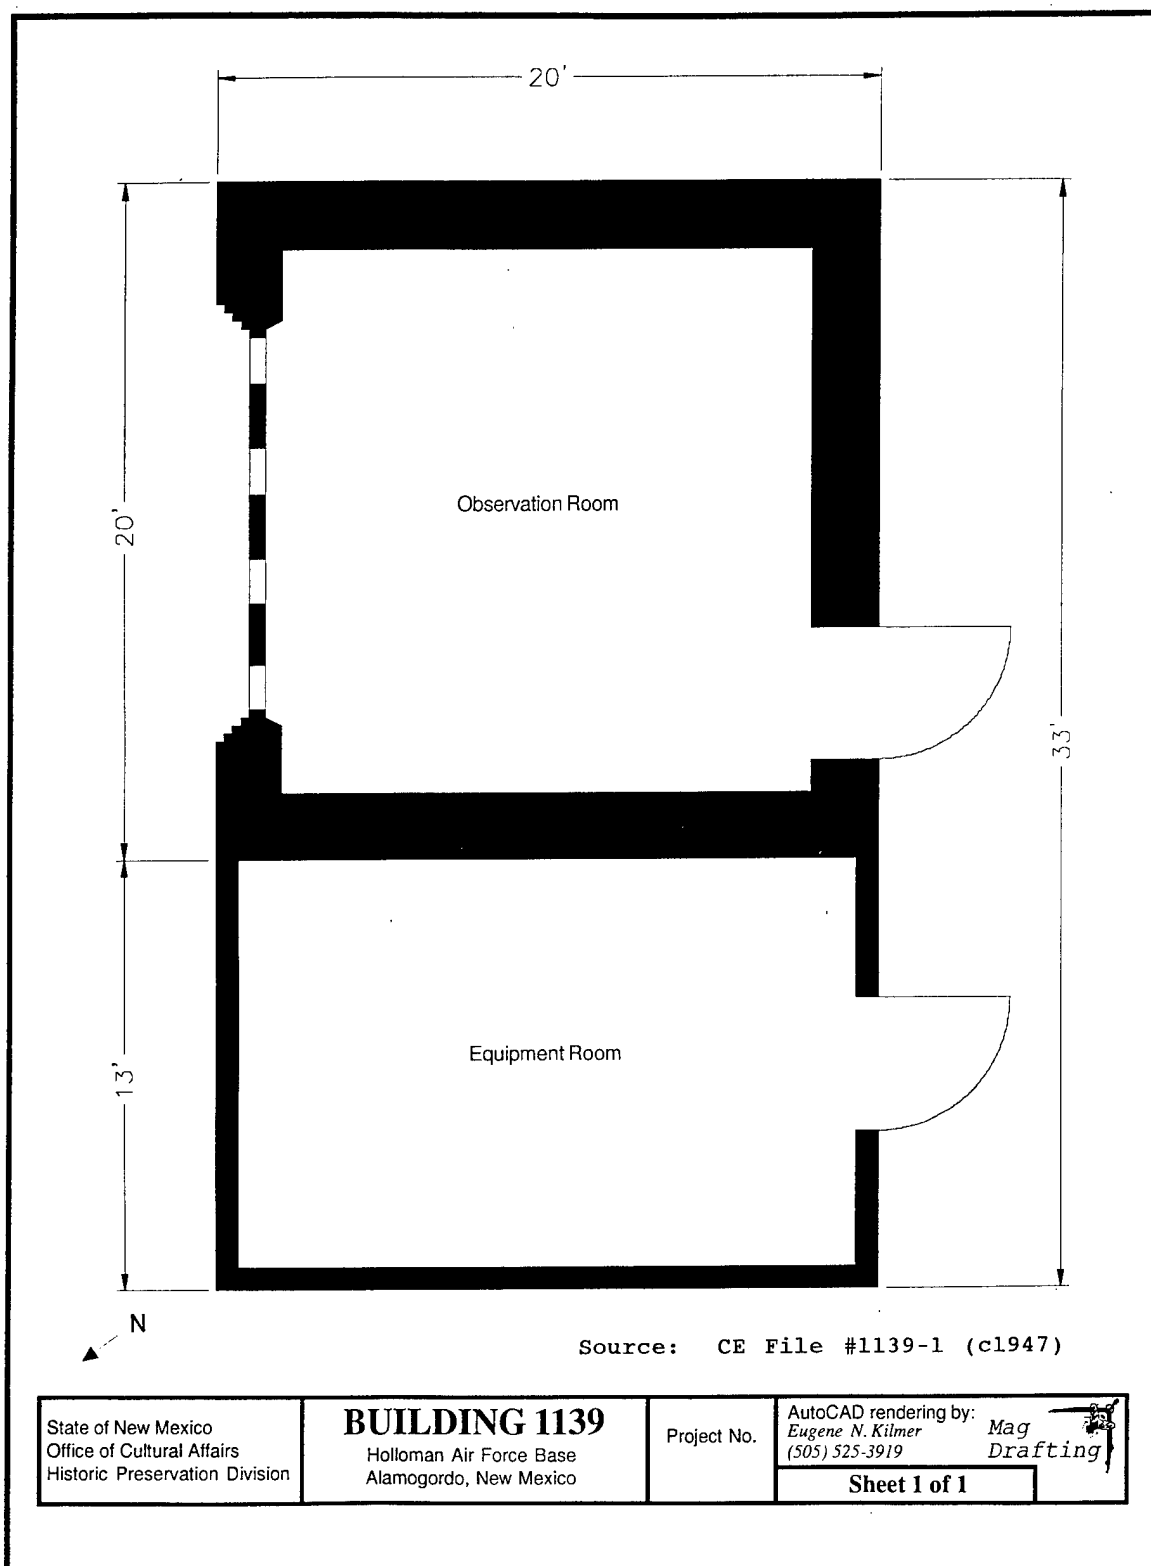
Figure 71. Building 1139, floor plan of the Gapa blockhouse, ca. 1947.

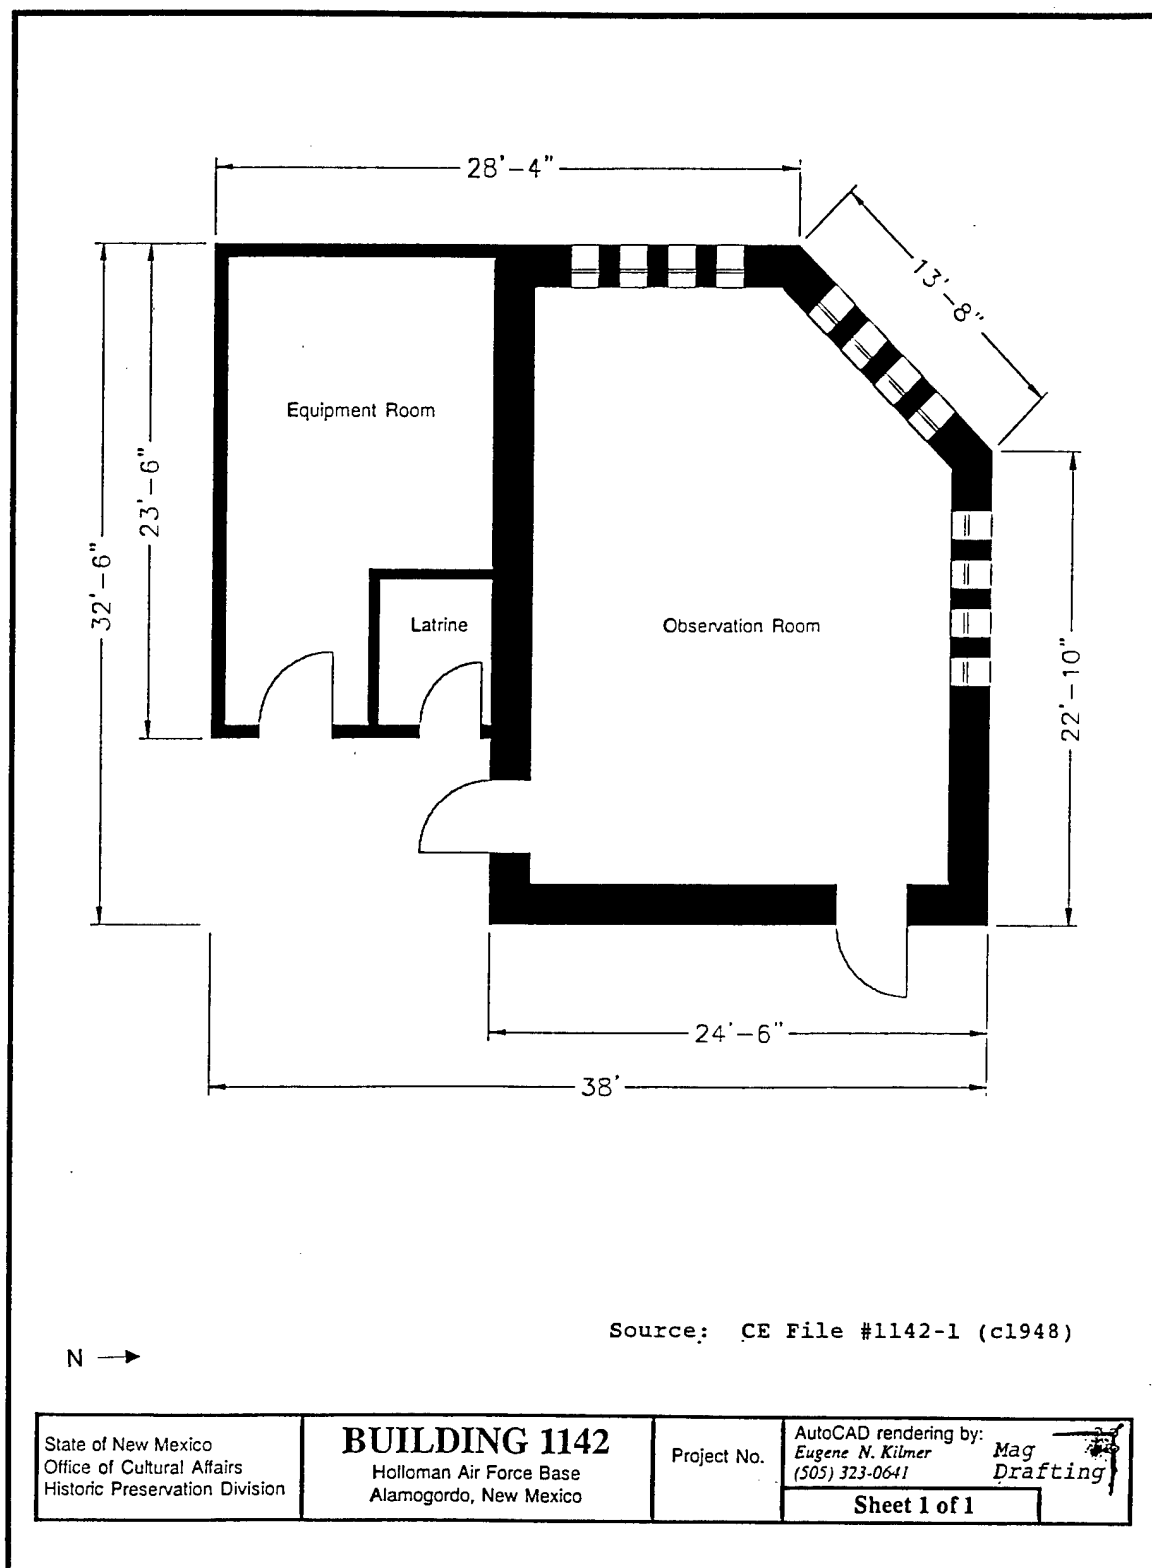
Figure 73. Building 1142, floor plan of the Aerobee blockhouse, ca. 1948.

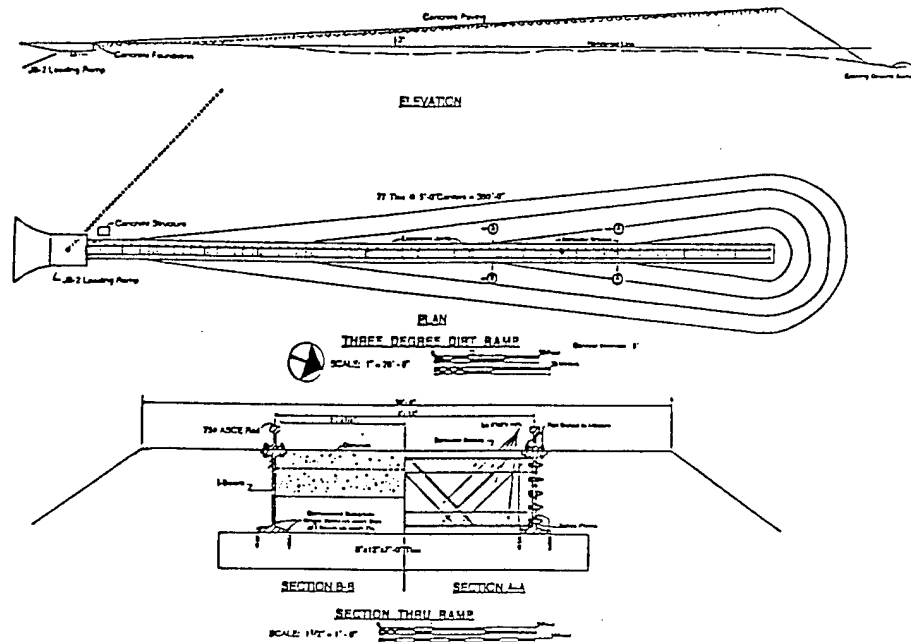
a. Original 1947 profile, plan and cross section.

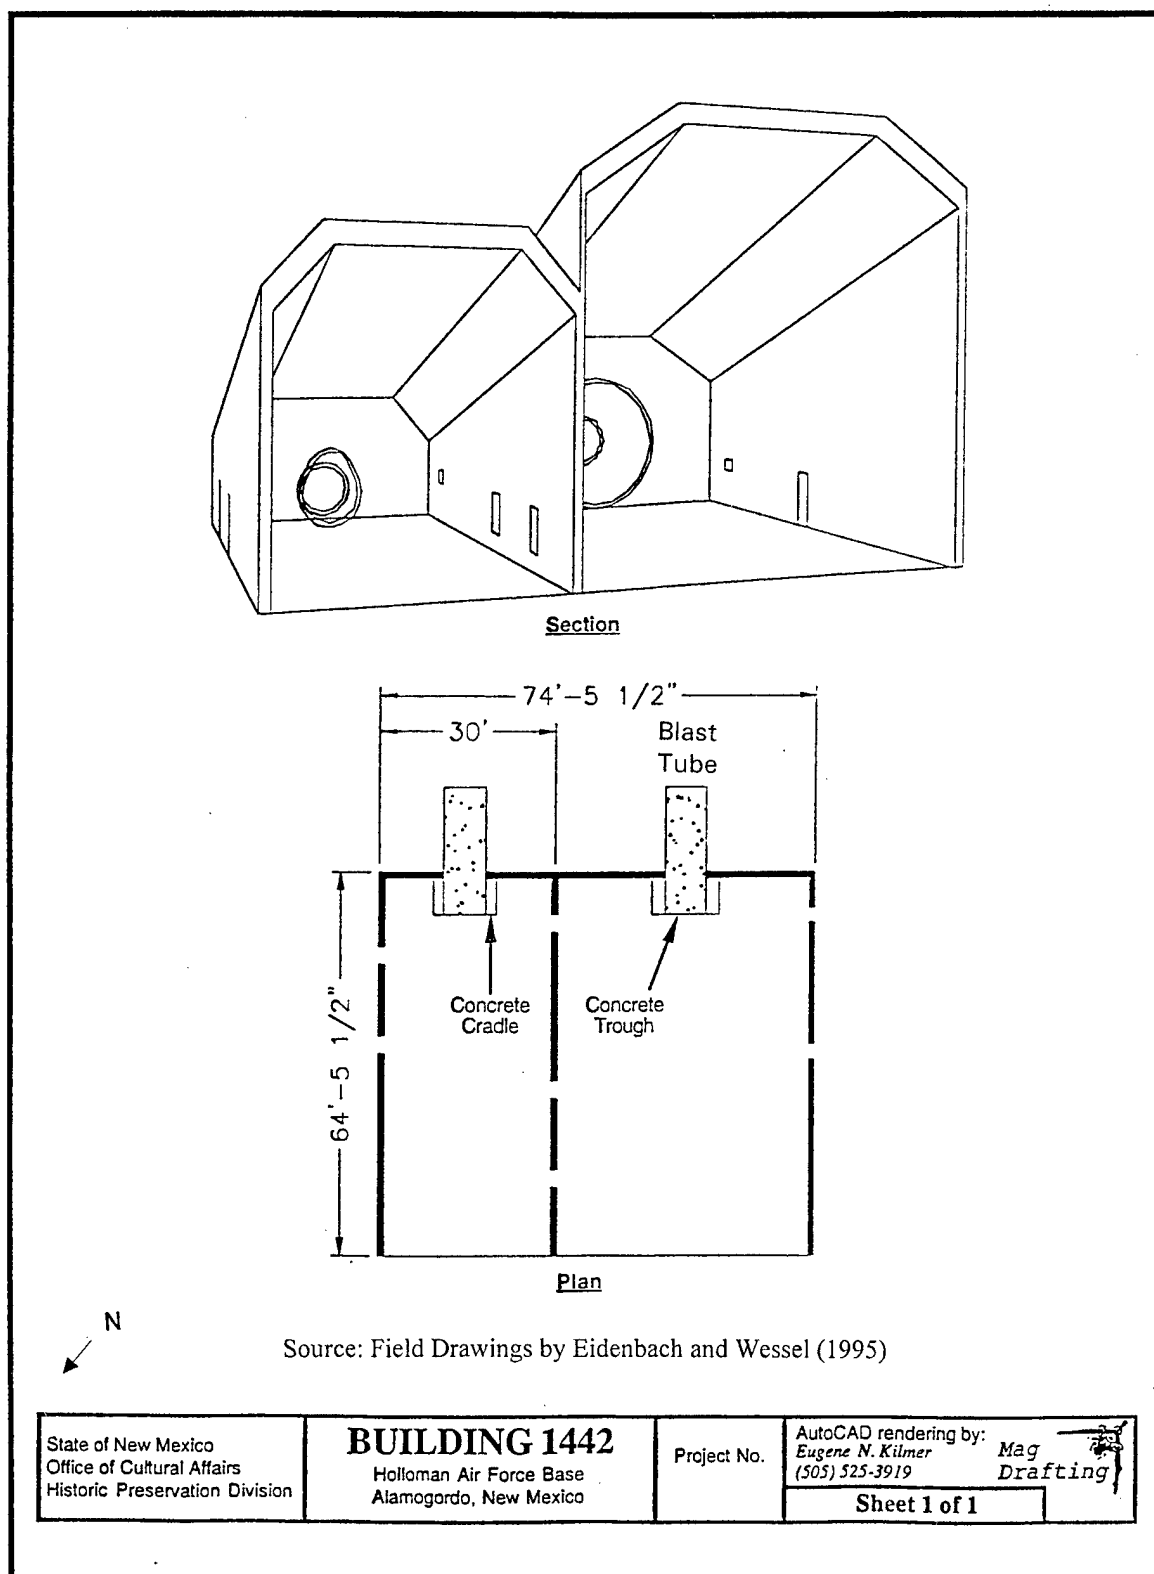
Figure 85. Building 1442, floor plan and 3-D profile of Able 51/ZEL site launch facility, ca. 1994.

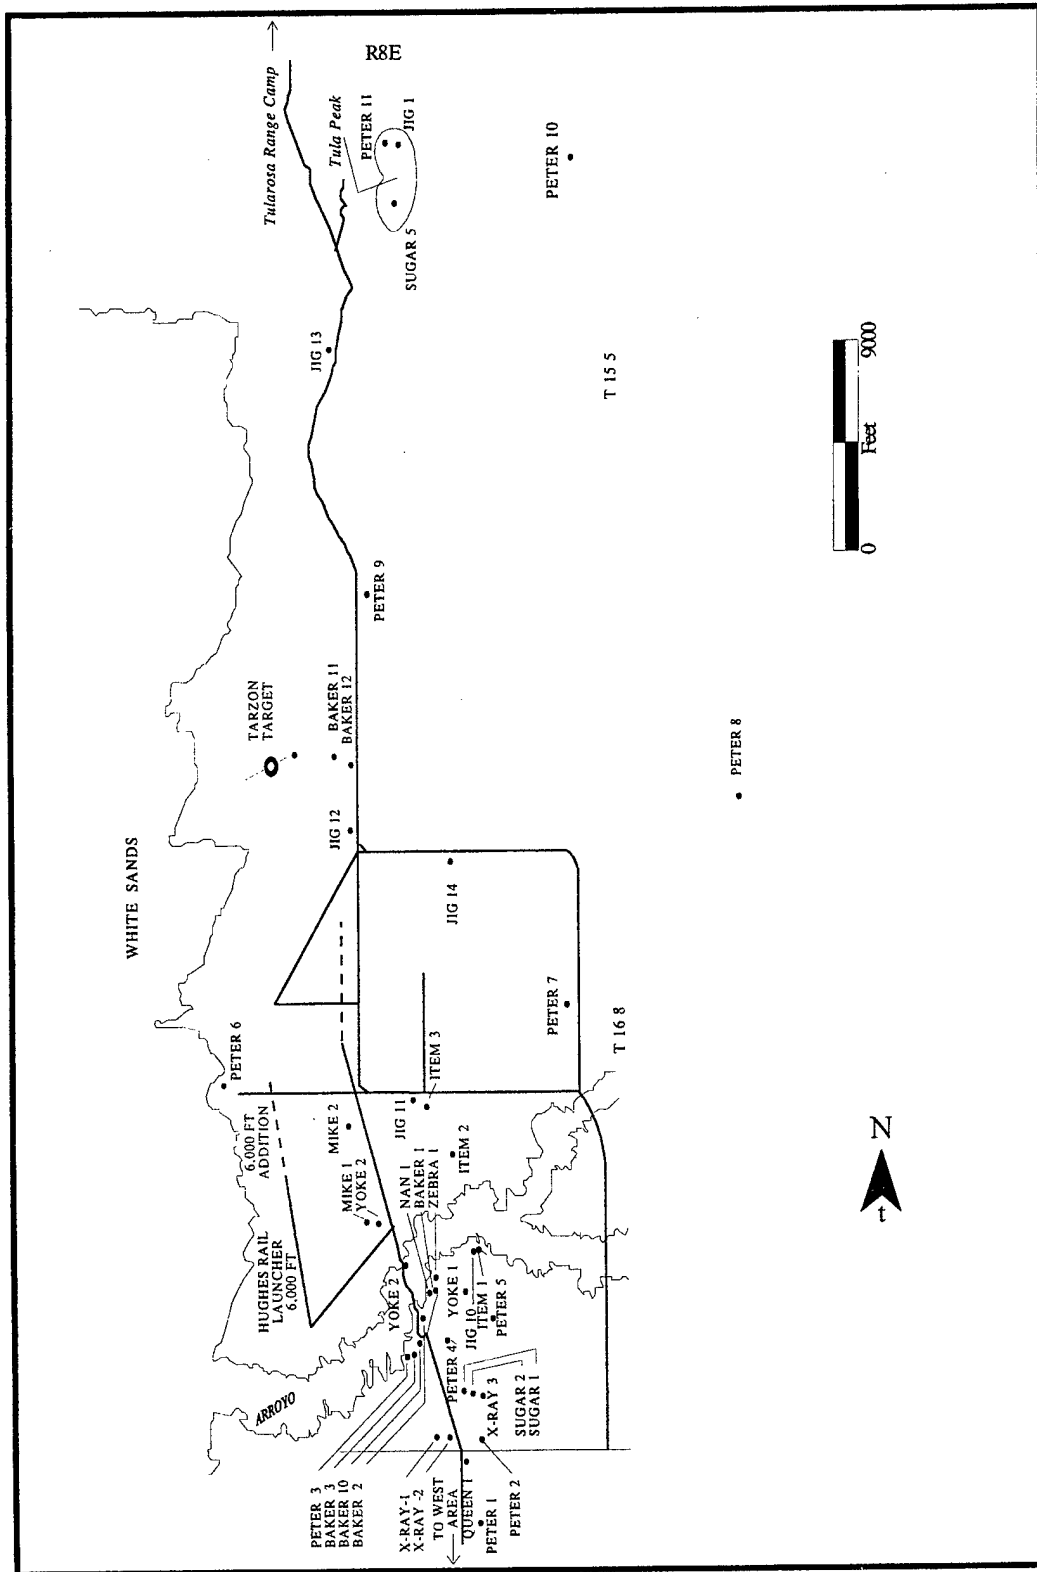
Figure 86. "Present arrangement of the optical and electronic instrumentation at HAFB", ca. 1949 (adapted from Holloman Air Development Center 1949:7).

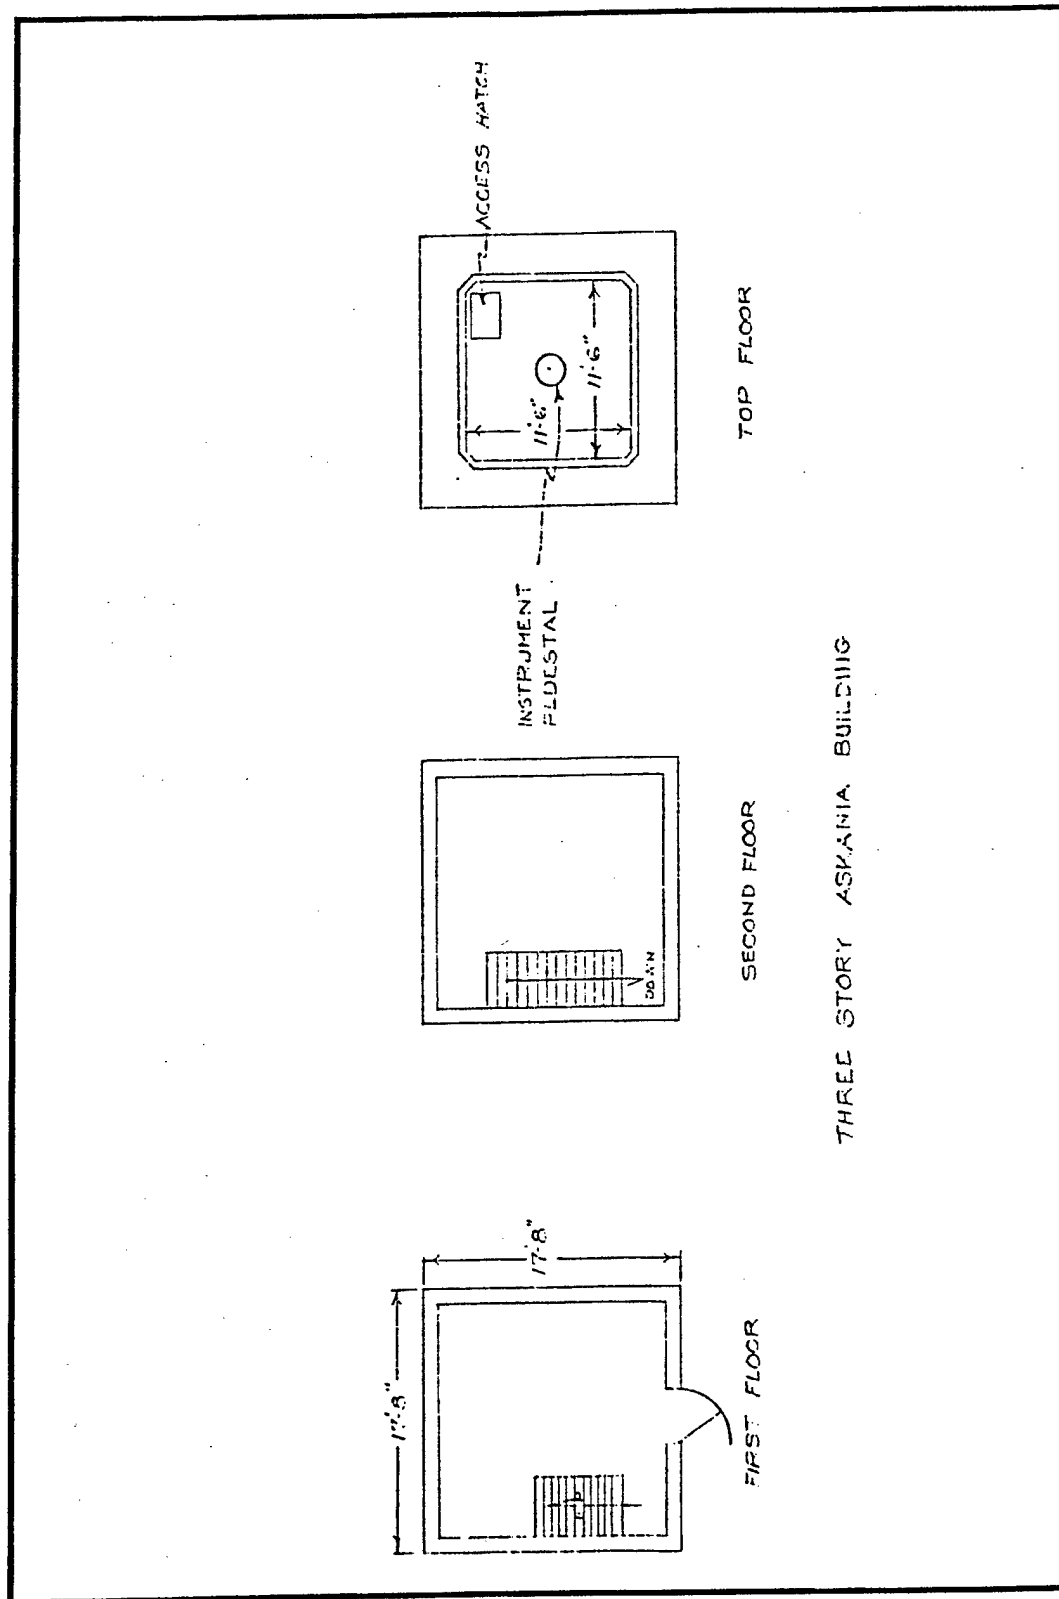
Figure 90. Building 900 (Mart site), plan view of "three story Askania building", ca. 1964 (Dynalectron Corporation 1964).

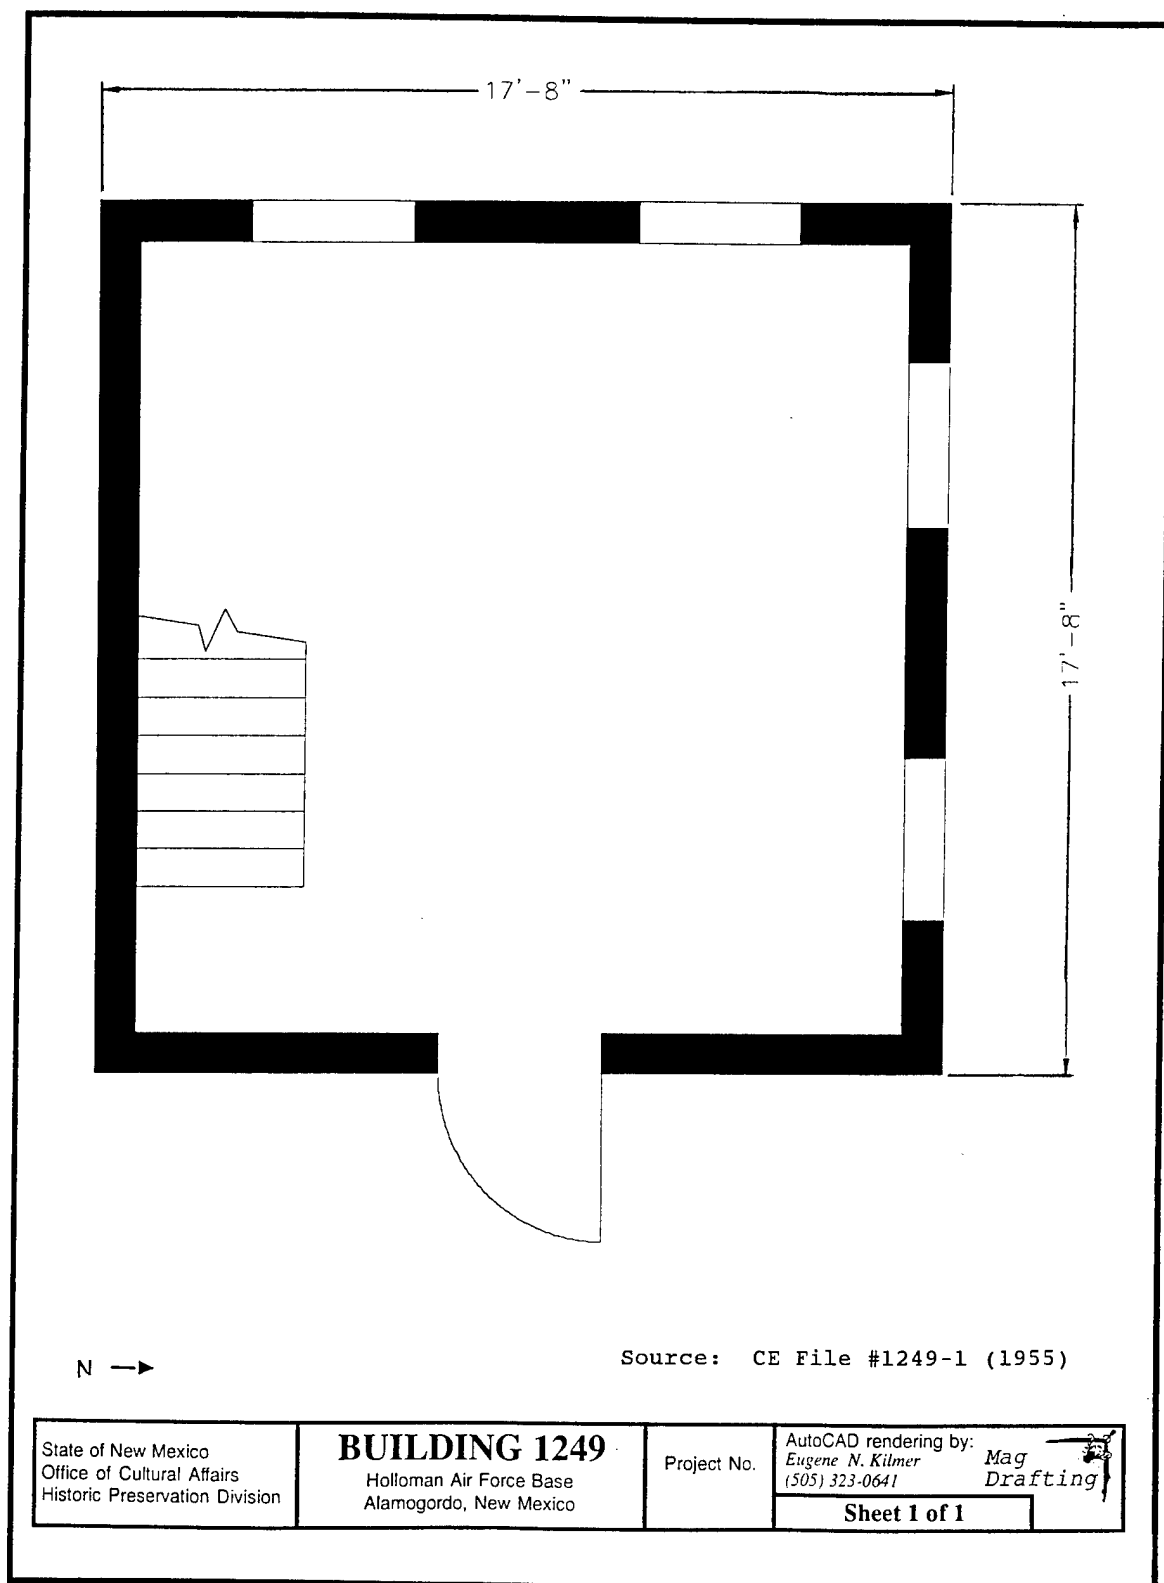
Figure 96. Building 1249, plan view of a Missile Theodolite Station, ca. 1955.
